# Manhole Inspection Summary

Manhole # S57A\_\_021MH

**Inspection** ☐ Is Incomplete Rating: **3) Fair**

**Location** Address: **400 haven st**

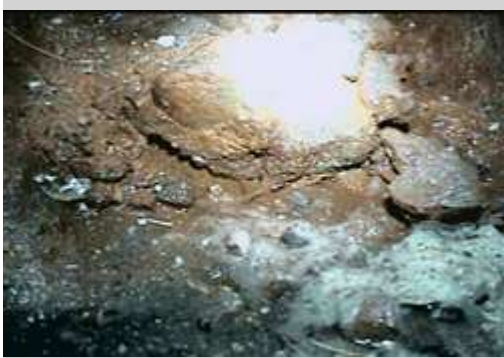
Defect 4

Condition: ☐ Sound ☐ Cracked ☐ Root Intrusion ☐ Deteriorated ☐ Leaks ☒ **Debris**

channel debris

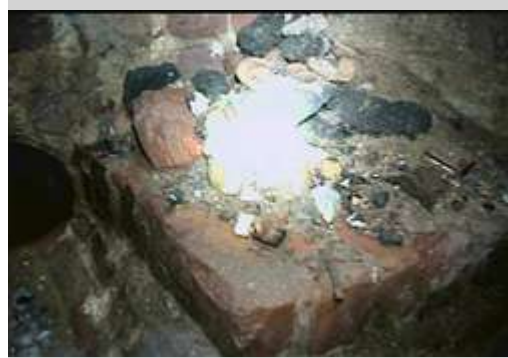
Defect 3

Condition: ☐ Sound ☐ Cracked ☐ Root Intrusion ☐ Deteriorated ☐ Leaks ☒ **Debris**

bench debris

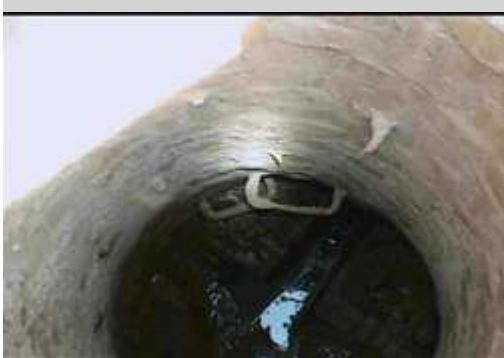
Defect 2

Count: **4** Missing: **2** ☒ **Corroded**

steps

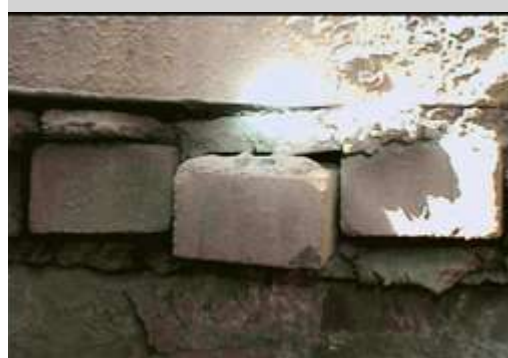
Defect 1

Condition: ☐ Sound ☐ Cracked ☐ Root Intrusion ☒ **Loose Brick** ☒ **Deteriorated**

Infiltration: ☐ None ☐ Joint ☐ Cracks ☒ **Mortar** ☐ Roots ☐ Wall

loose bricks, deteriorated

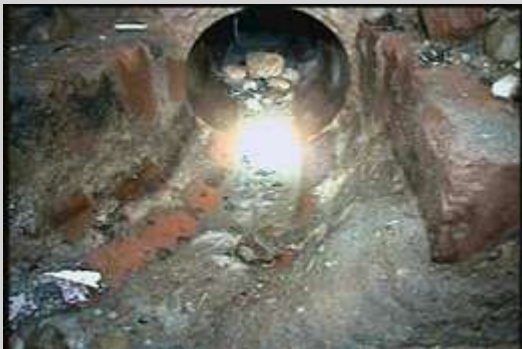
3 O'Clock Inflow

Deposits: ☐ None ☐ Mud ☐ Sludge ☒ **Debris** ☐ Grease

Silt Depth: 4 (in.) Deposits Extent: **Medium**

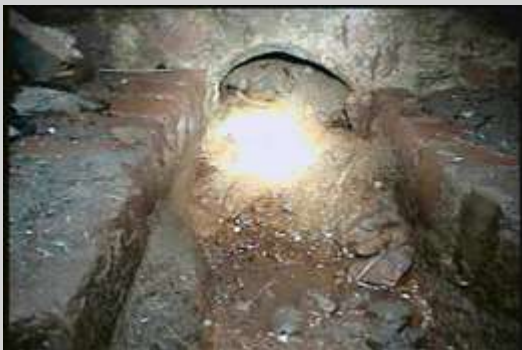
9 O'Clock Inflow

Deposits: ☐ None ☐ Mud ☐ Sludge ☒ **Debris** ☐ Grease

Silt Depth: 7.5 (in.) Deposits Extent: **Heavy**
